PROJECT PROFILE
UK20-039

## Teretek® Used to Fill Void Under 4,500m² Research Laboratory

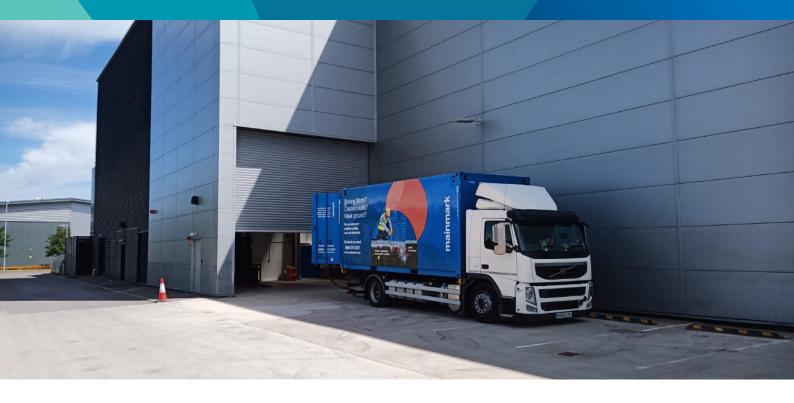
A five story 4,500m² applied science laboratory building used by approximately 1,200 people who support the work of over 10,000 scientists and engineers, had become unstable. Housing a number of large vacuum chambers, the drainage system under part of the building had not performed as intended and, as a result, voids had formed under the concrete slab.

Mainmark's engineered resin injection solution Teretek® was ideally suited to the 1,600m² work area; its keyhole surgery approach eliminating the need for disruptive, expensive and lengthy work to replace the internal floor slab.

Small incisions were drilled at even spaces throughout the floor area, allowing the expansive geopolymer resin to be injected into the sub-base directly under the internal floor slab, providing uniform treatment throughout the surface area and filling the void underneath. Using this keyhole technique, the solution was delivered in a way that created minimal mess and was flexible enough to work around the day-to-day operations of the lab and meet the client's requirements.

In just 11 days, Mainmark successfully treated the foundation ground with Teretek resin, filling the voiding directly beneath the ground bearing floor slab as required, working to strict minimal dust requirements, saving the client time and money. Without the resin injection solution, this job would have involved a full building demolition and rebuild, resulting in significant disruption and operational capacity for the client.
