Teretek® Used to Fill Multiple Voids in Residential Housing Estate

Two-storey semi-detached brick houses

Maidstone, Kent

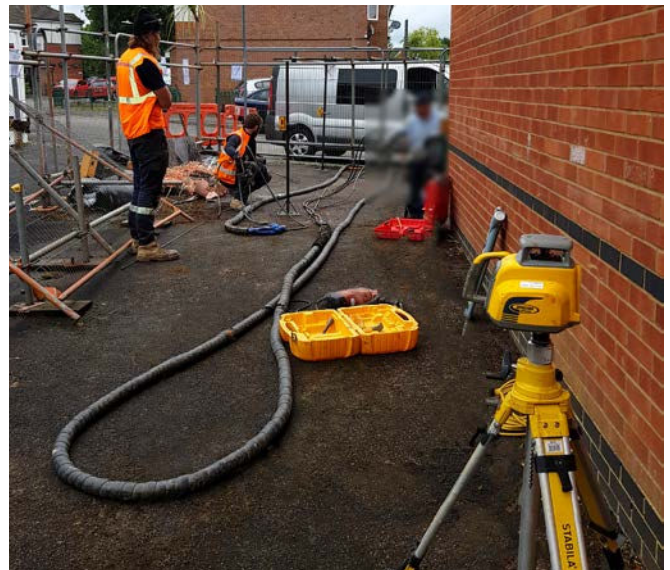
Teretek® resin being injected to fill the voiding and stabilise the top layers of ground in one of the designated areas on the property

The key treatment area was outside of the house, around the car park and general grounds, with only a small section of the building itself needed remediating. Mainmark injected Teretek resin in a grid pattern in the designated areas to ensure a consistent layer of resin was injected across all the voids of various sizes, some significant; approximately 24 metres deep and 6-9m in diameter.
