Teretek® Raises and Re-levels Concrete Slabs at Busy International Airport

PROJECT PROFILE

UK21-800

Belfast International Airport, Belfast, Northern Ireland

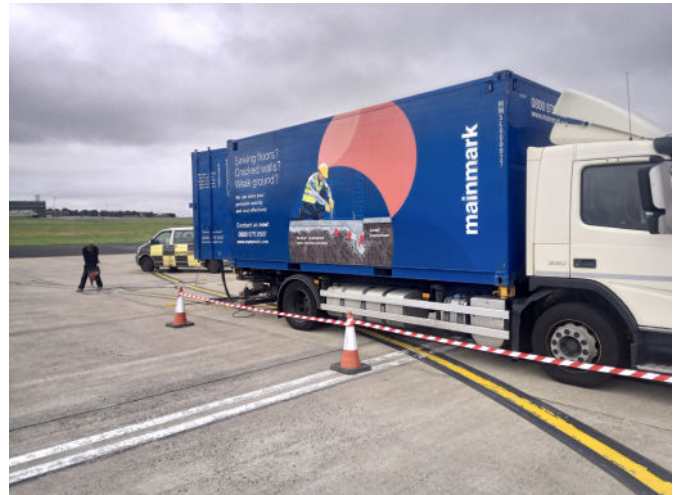
Resin injection being carried out on the taxiway

To minimise disruption, Mainmark completed work in between aircraft arrivals. To lift the concrete slabs, Mainmark utilised Teretek®, its proprietary two-in-one resin injection solution, as it's fast-acting, cost-effective, and requires no excavation making it ideal for this project.

Upon starting the work, the Mainmark team discovered that the slabs were 1.4m thick, which was significantly more than expected and additional drilling was required. Nevertheless, Mainmark was able to finish the project on time, lifting the slabs by up to 44mm in some places, by applying Teretek in a targeted injection sequence, 2m below ground level.

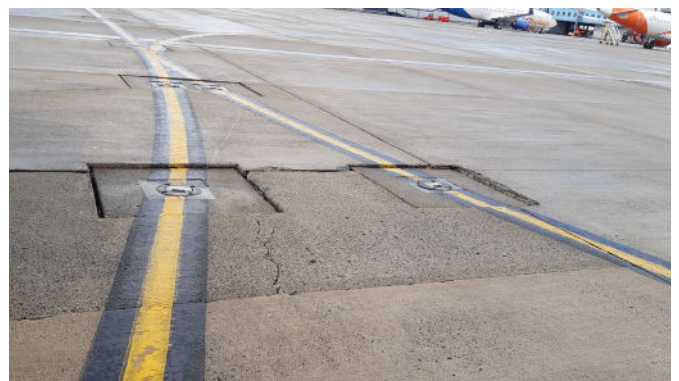
A cargo access taxiway, just off Lima taxiway at BIA was suffering from subsidence, causing three 2m² by 1.4m thick concrete slabs to sink by up to 66mm.

With around 30 aircraft using the taxiway each day, safety, as well as comfort, are critical factors and the taxiway needs to be level. Recent subsidence had caused gaps/steps to appear between several slabs, and movement over the slab joints caused concern for aircraft and support vehicles, with the effects most noticeable at the radar dome, or 'nose' of the planes. As a result of these concerns, the airport needed to rectify this issue.

Taxiway "before" resin injection

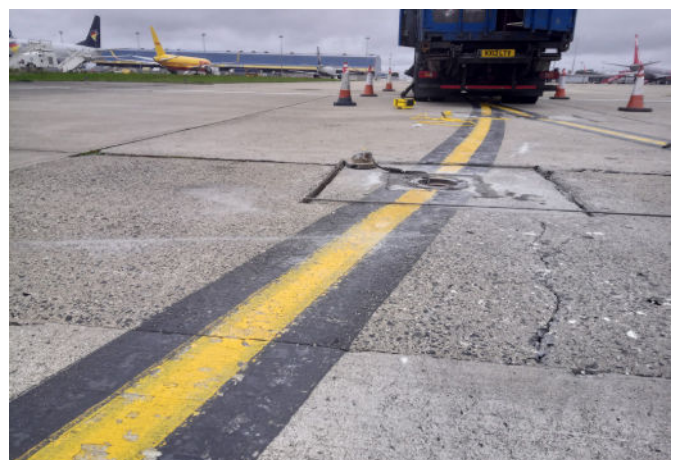
Taxiway "after" resin injection

Mainmark completed the project in one day and the slabs were ready to be used immediately after injection, helping to keep the taxiway operational.
