# Oxfordshire Recycling Centre Restored with Teretek®

Home Waste and Recycling Centre

Unstable ground and damage to road surfaces

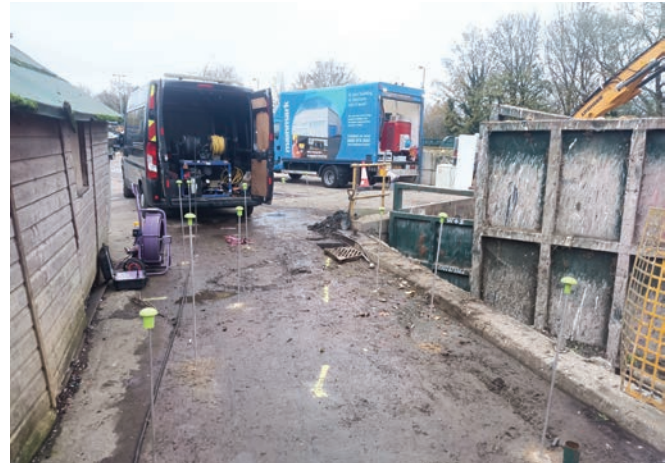
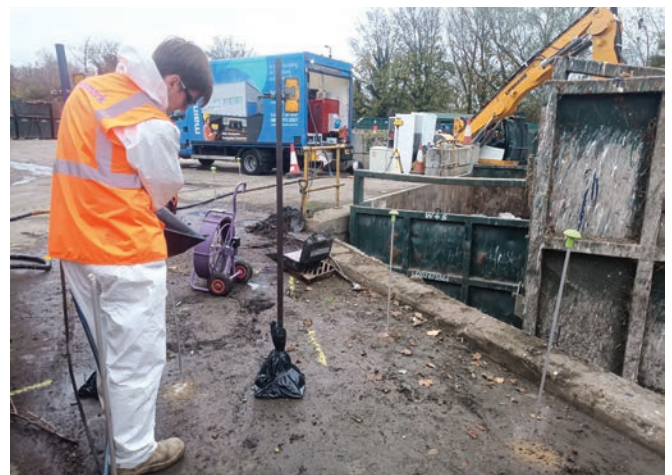
Above: During resin injection

To complete the reconditioning of the 100m<sup>2</sup> of affected road, Mainmark was required to drill 16mm holes in a grid pattern at 1.5m centres, reaching a necessary depth of 1m below the ground. To help ensure that the drainage system below was not affected by the works, drainage monitoring actively took place throughout to process.
