# JOG and Teretek<sup>®</sup> Used to Raise and Re-level Three Business Units in East London

Manor Way Business Centre, Rainham, Essex, United Kingdom

DURATION / YEAR August – November 2021

LTECHNOLOGY JOG Computer-Controlled Grouting and Teretek®

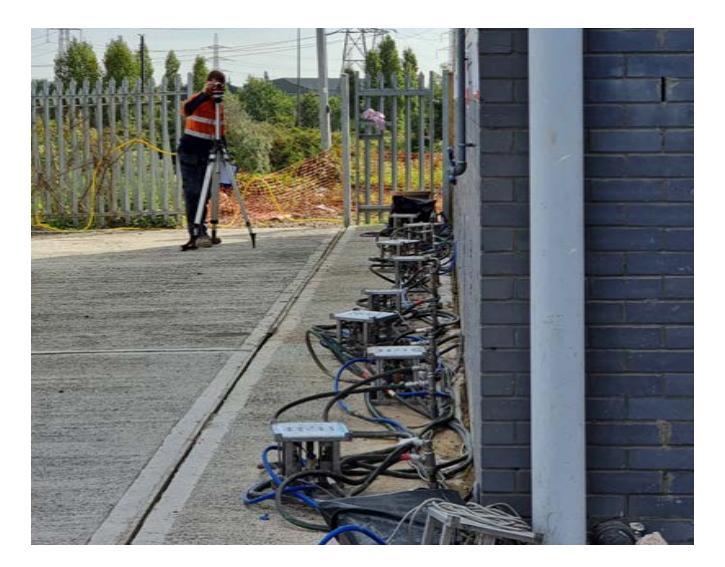
Above: A Mainmark technician checking building levels and the non-invasive JOG Computer-Controlled Grouting injectors placed around the exterior of one of the units.

The perimeter of the buildings needed work to help repair the prevalent cracks, as well as improve the weakened ground and fill the voids. Therefore, Teretek resin injection was initially used to strengthen the weak ground under the buildings, whilst JOG was deployed using pin-point technology to facilitate non-invasive, accurate, and fast-acting computer-controlled grouting to lift the structures in a complementary approach.

JOG was also utilised within the interior to provide relief to the load-bearing walls and, inside the buildings, Teretek was used alongside JOG to fill voids and re-establish and re-level the sunken floors. This combination method was paramount to maintain the integrity of the buildings, helping to make them safe for staff to use once more. Mainmark was able to successfully treat approximately 55 lineal metres or 990m<sup>2</sup> across buildings 1 and 3, with a further 1300m<sup>2</sup> or 66 lineal metres for building 2.
