Teretek® Raises and Re-supports Factory Floor For a Safer Working Environment

PROJECT PROFILE

2016-09UK

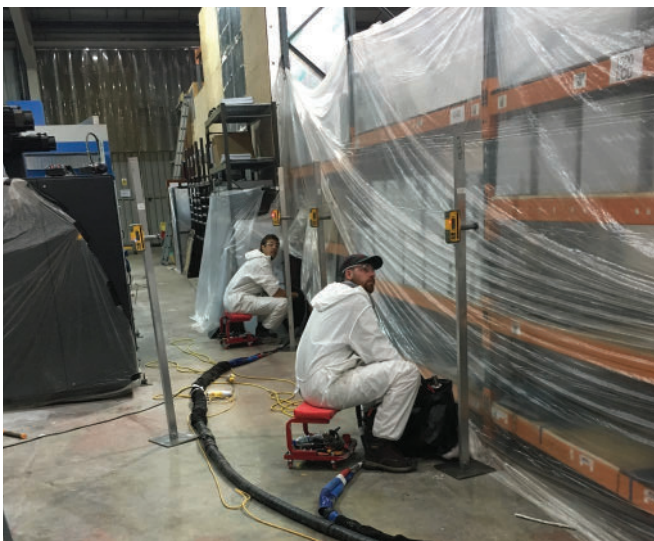
Mainmark Technicians injecting Teretek® engineered resin while monitoring the lift using a laser-receiver

Teretek was applied through a highly targeted injection pattern, which carefully and precisely lifted the floor the required 180mm. The Mainmark team constantly monitored the floor level using lasers for pinpoint accuracy.

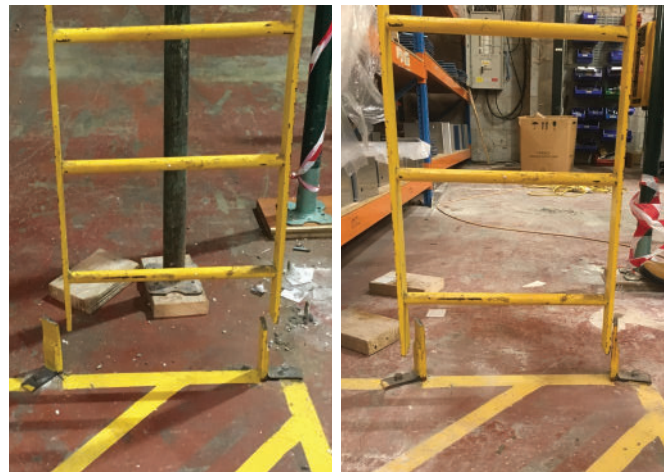
Ladder positioning before and after re-levelling work with Teretek® resin injection
