# Teretek<sup>®</sup> Re-levels and Supports Home Built on Sloping, Unstable Soil

PROBLEM Weak soil and subsidence

LOCATION Newton Abbot, UK

DURATION / YEAR 3 days / 2017

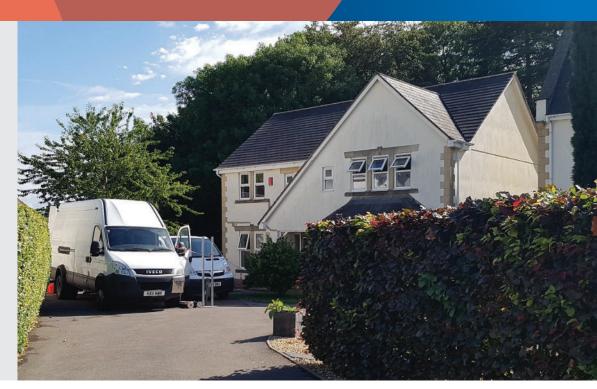
The structure stood on 1.5m deep strip footings and a suspended, reinforced concrete floor slab. Half of the home had subsided approximately 40mm, causing the wall of the house to separate from the foundation by approximately 20mm. Large cracks also began to form in the walls.

Wall crack before and after  $\mbox{Teretek}^{\otimes}$  engineered resin being injected

Mainmark recommended Teretek<sup>®</sup>, its proprietary engineered resin injection solution, due to its ability to raise and re-level the structure in a prompt, non-invasive fashion so as to allow other trades to work around the methodology. This noninvasive, environmentally-inert solution successfully returned the house to level and closed the cracks.
