Northamptonshire Warehouse Receives Bespoke Foundation Lift to Save Main Office

PROJECT PROFILE

2018-22UK

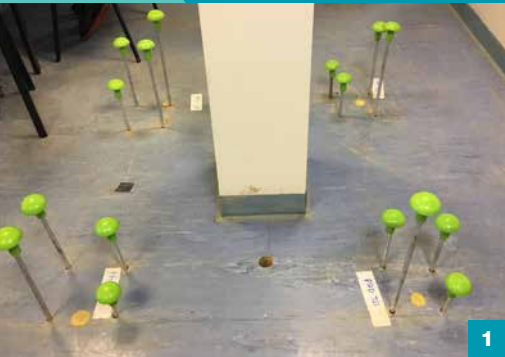
Above: 1. Teretek injection points were carefully planned within the structure's interior
2. JOG Computer-Controlled Grout was used in both the interior and exterior to gradually bring structures back to level
3. The poor strata under the office building caused it to sink.

Grouting technology to lift the building and its proprietary Teretek resin injection solution to provide the necessary ground improvement, as well as raise and void fill the internal floor slab.

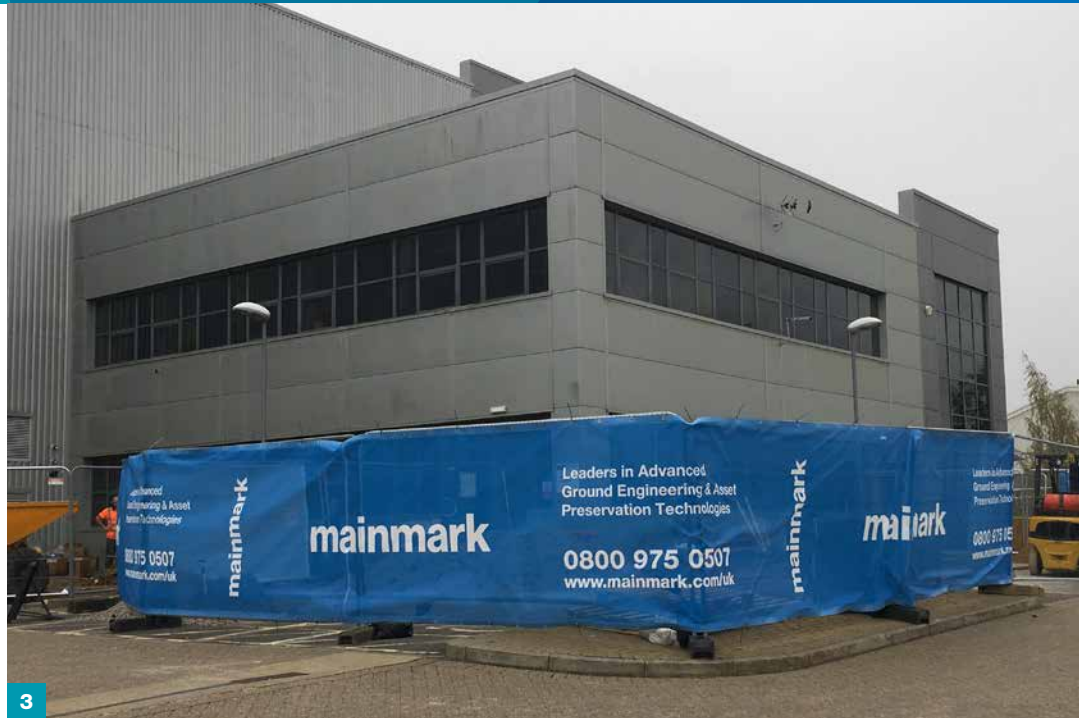
The office building attached to the distribution warehouse had sunk by approximately 70mm due to the poor underlying strata of made ground that had failed at certain depths. As well as hosting the main general office, used by approximately 20 employees each day, the smaller building attached to the distribution warehouse also contains the staff canteen, shower rooms and toilets, as well as punch-in clocks; areas regularly facilitated by both office and warehouse workers.

The office was raised by 57mm, with the ground improved to the required specification and, due to the work completed, Mainmark has provided a long-term solution to the ground issues.
