Teretek® Used to Reinforce Ground of Victorian Villa

PROJECT PROFILE

UK21-248

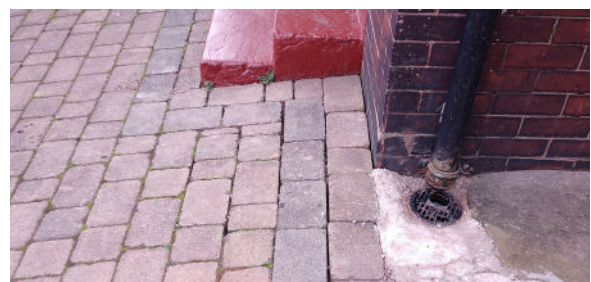
Corner of house re-levelled

To rectify the issues, Mainmark's proprietary non-invasive Teretek® resin was injected in six locations from 1.5m to 2.5ms down at each location to fill any voids and reinforce the weak ground. To help ensure even distribution, injection took place at each point until laser measurements indicated a positive lift of between 2 and 4mm along the length of the treated areas. A drainage engineer was also present and carried out CCTV drain surveillance whilst the resin injection process took place to ensure no resin entered into any cracks or joints in the drains during the injection process.

The ground strength post-test carried out by Mainmark showed a marked improvement and the project was completed within just one day. Mainmark delivered the important ground improvement as a priority and was also able to raise the structure by 4mm which generated noticeable crack closure. After completing the works, all injection holes were grouted and the drains were checked and declared clear as required. The project was completed on time and in budget, faster than alternative solutions could have provided.

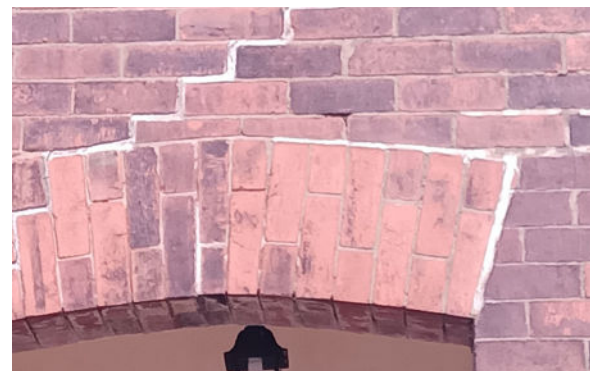
Step crack closed up and repaired
